Otoscopic Findings

This page shows some of the common abnormalities that one can see when the eardrum is examined.

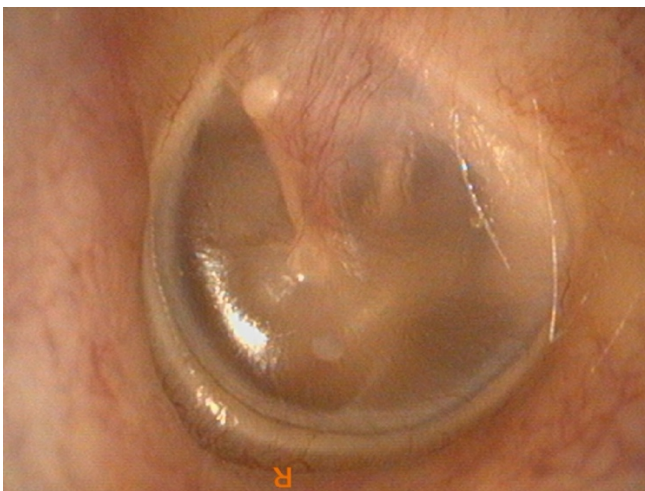
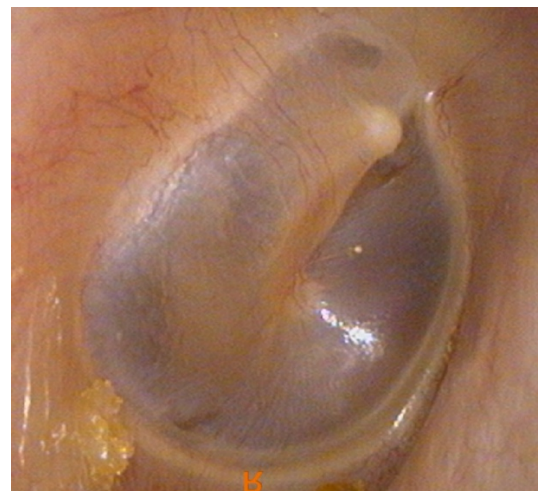
Normal Drums

The normal ear drum is translucent and casts back a light reflex from its antero-inferior quadrant. Often one can see middle ear structures through it.

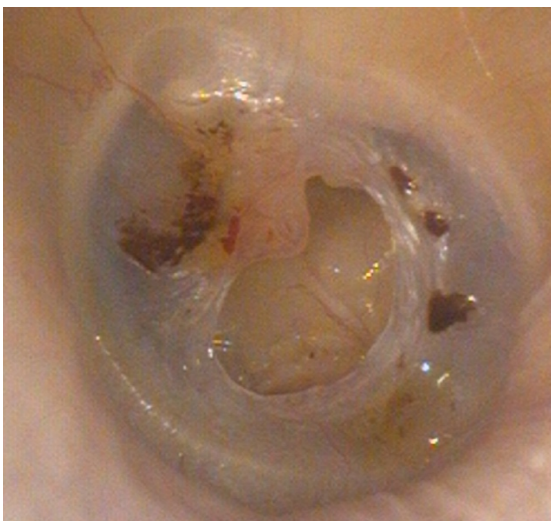
There is a hole in the centre of this eardrum and scattered blood clots. This perforation was caused by a slap on the ear.

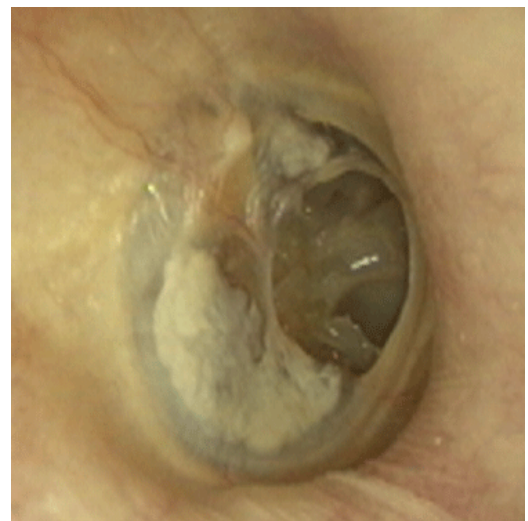
This left ear has a central perforation posteriorly. It is clean. There is tympanosclerosis anteriorly but this is not important.

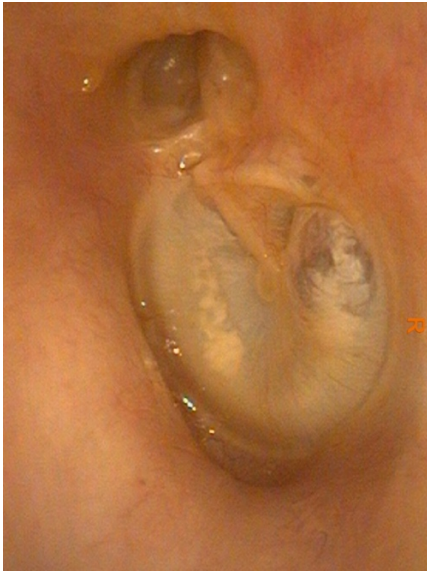
This drum shows a retraction in the attic. This is an area of the drum that has been sucked inwards by chronic negative middle ear pressure.

The neck of the malleus can be seen under the retraction. Such retractions may go on to become a cholesteatoma.

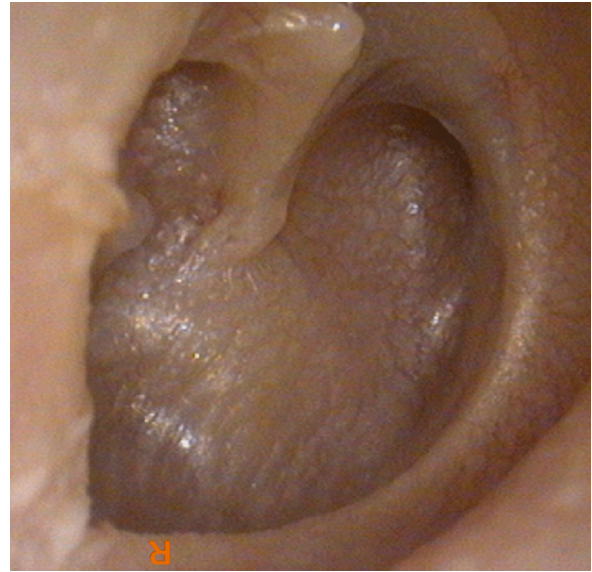
This drum is completely retracted. It has collapsed onto the promontory. The stapes head can just be seen posteriorly
